# Manhole Inspection Summary

Manhole # S11MM1027MH

Insp Date: **6/4/07 1:34 PM**

**Location** Address: **3139 VIRGINIA AVE**

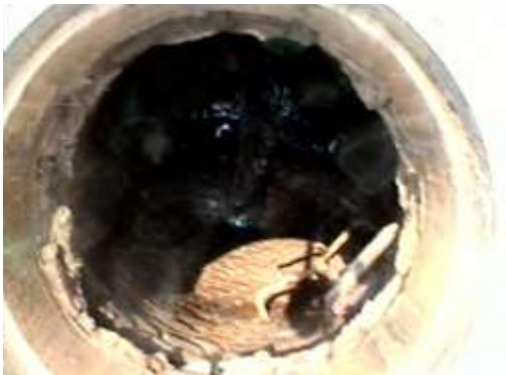
Defect 2

Condition: **Cracked**

Condition: ☐ Sound ☒ **Cracked** ☐ Leaks

CRACKED FRAME

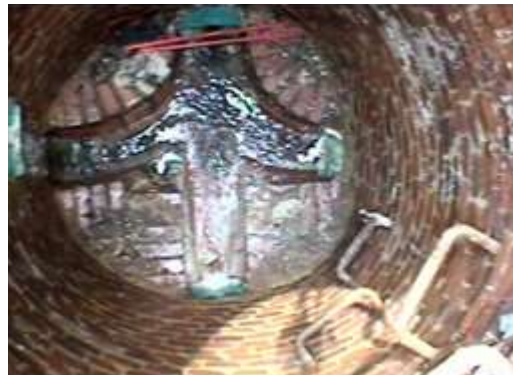
Defect 1

Count: **5** Missing: **0** ☒ **Corroded**

CORRODED STEPS, AND DEBRIS IN CHANNEL AND BENCH

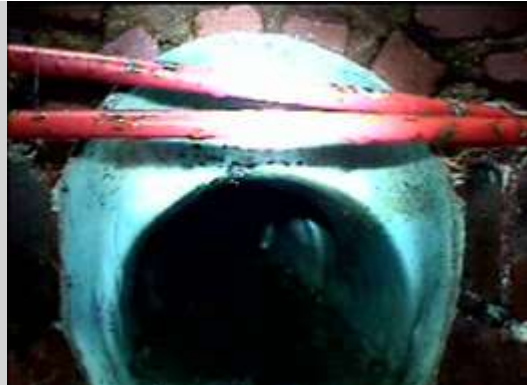
12 O'Clock Outflow

10 in. Circular Gravity Sewer  
Pipe Out @ 12 O'Clock

Invert Depth: **10.02** (ft.) Flow Characteristics: **Fast**

Infiltration: **None** Pipe Seal Cond: **Sound**

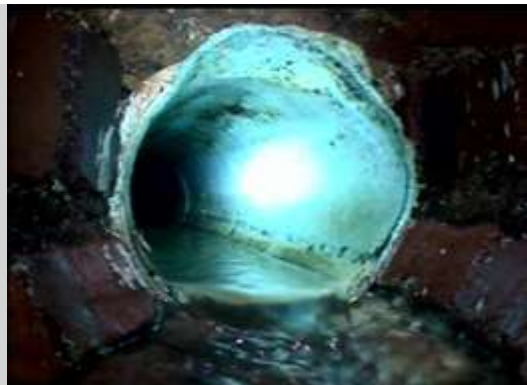
3 O'Clock Inflow

8 in. Circular Gravity Sewer  
Pipe In @ 3 O'Clock

Invert Depth: **9.98** (ft.) Flow Characteristics: **Slow**

Infiltration: **None** Pipe Seal Cond: **Sound**

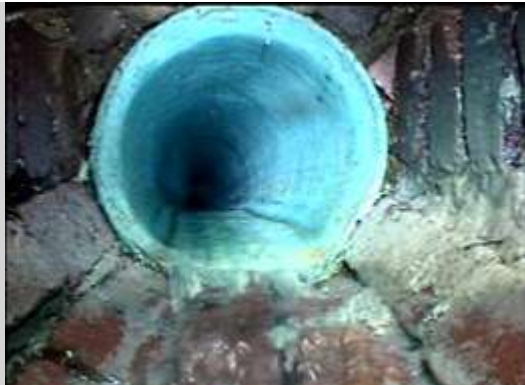
6 O'Clock Inflow

Invert Depth: **9.88** (ft.) Flow Characteristics: **Fast**

Infiltration: **None** Pipe Seal Cond: **Sound**

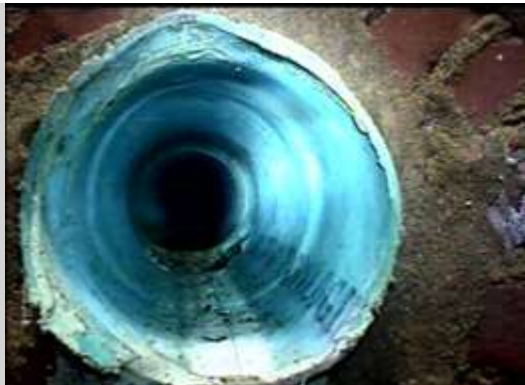
9 O'Clock Inflow

Invert Depth: **5.40** (ft.) Flow Characteristics: **Slow**

Infiltration: **None** Pipe Seal Cond: **Sound**

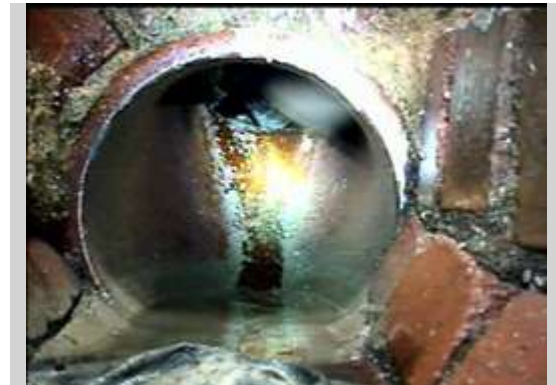
Drop In @ 9 O'Clock

Drop: **Outside Direct**

Inv Depth: **9.75** (ft.)

Drop Condition: **Open**
